Manhole Inspection Summary

Manhole # S37SS_022MH

Location Address: **2708 MATHEWS ST**

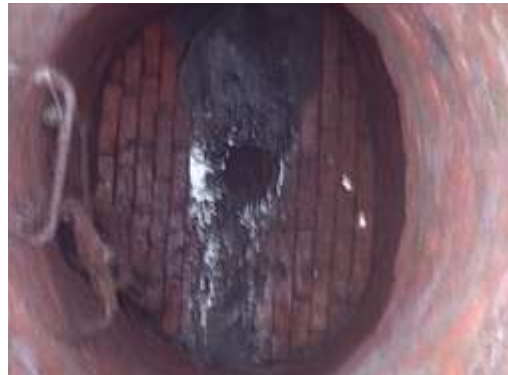
Top View

Adjustment, Corbel and Barrel infiltration.
Corroded steps. Channel debris.

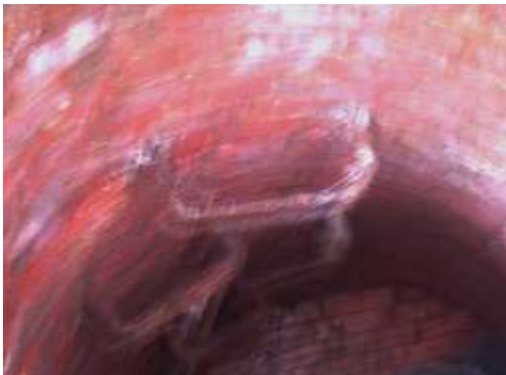
Defect

Adjustment, Corbel and Barrel infiltration.

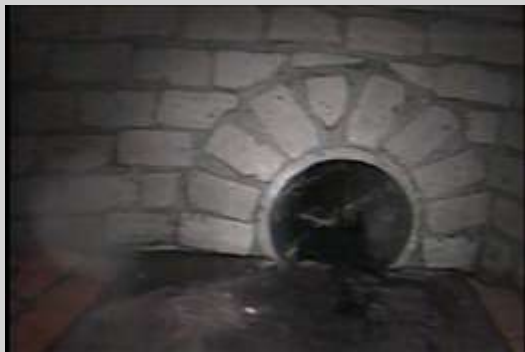
8 in. Circular Gravity Sewer Pipe Out @ 12 O'Clock

Deposits: ☐ None ☒ **Mud** ☐ Sludge ☒ **Debris** ☐ Grease

Silt Depth: **0.5** (in.) Deposits Extent: **Light**

Infiltration: **None** Pipe Seal Cond: **Unknown**

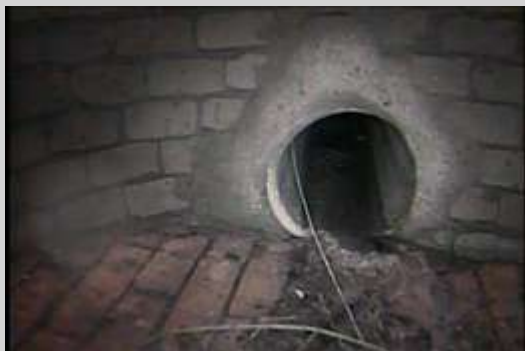
8 in. Circular Gravity Sewer Pipe In @ 6 O'Clock

Deposits: ☐ None ☒ **Mud** ☐ Sludge ☒ **Debris** ☐ Grease

Silt Depth: **0.5** (in.) Deposits Extent: **Light**

Infiltration: **Evidence** Pipe Seal Cond: **Unknown**
